100E into E83W will go (just)

(The story of how Noddy, an E83W pick-up, received a 100E engine)

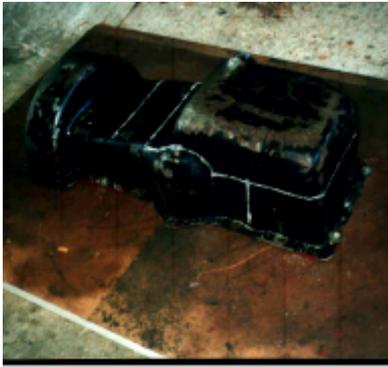
Original sump marked-up for cutting.

The shape of the sump (deep part at the front) is the most obvious problem when considering the installation of a 100E engine in any 'upright' Ford. They have their front axle and steering rods just below the front of the engine. The way to do it when converting a car has been well documented but the E83W has heavier steering and suspension and more ground clearance than the cars so even the deep part is well clear of the track rod. The photographs show various stages of the sump conversion which basically involves moving the deep part further back. It's not straightforward (nothing is) because the sump tapers towards the front and has a bulge at the side to accommodate the oil pump. If I were starting again the new front lower edge would be radiused rather than the sharp corner as shown, this turned out to be a very close fit to the flange on the chassis front cross member. During the welding process it is advisable to screw or clamp the sump flange to a suitable flat surface to avoid distortion. After welding fill it with paraffin to check for leaks.

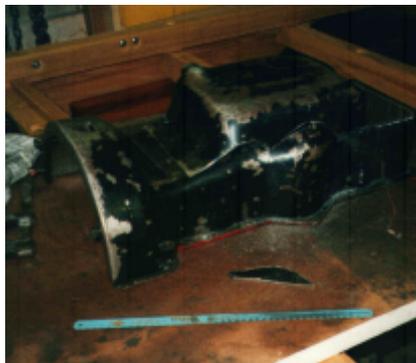
Deep part cut and moved back.

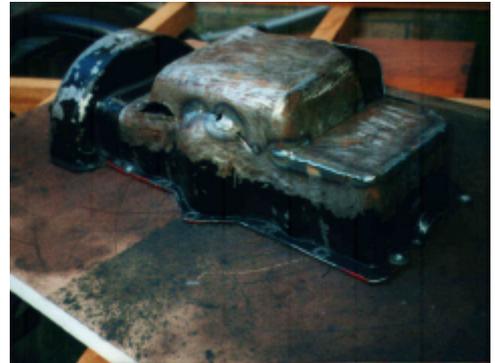
Part-way through the welding process.

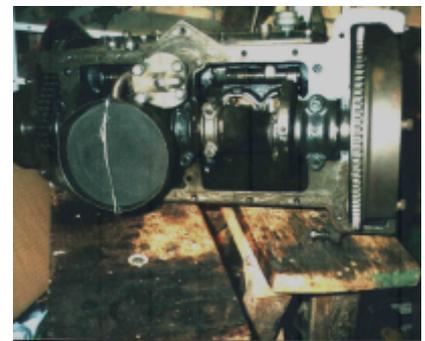
Oil pick-up pan in new position.

With the deep part of the sump repositioned it is necessary to move the oil pick-up but not by as much as when modifying for installation in a car. The necessary shift can be achieved by careful bending of the pipe between pick-up and pump. It is easier to check this when the main sump welding has been done but before all the holes are plated over. This allows you to see where the pick-up is fouling the sump during the bending process.

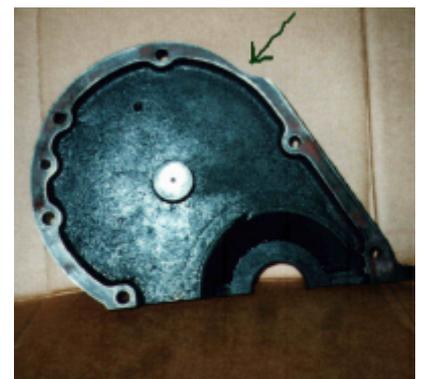
The timing chain cover after grinding to allow room for the water pump.

It is not practical to use the 100E engine mountings, which are on the sides of the engine, so the timing cover casting of the 93A must be retained in order to use the original engine front mounting bar. The castings are interchangeable but the old one will require a bit of grinding on the top edge to clear the water pump body. The picture shows that you should avoid being too heavy handed or the sealing face will be lost at this point.

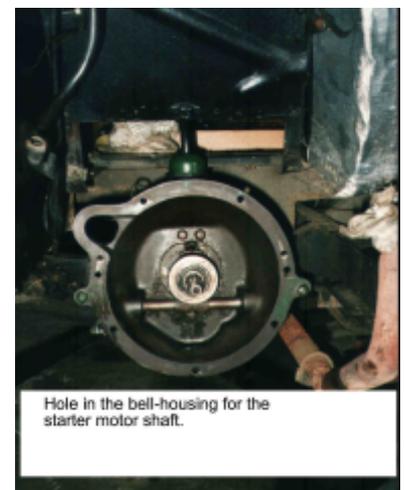
Hole in the bell-housing for the starter motor shaft.

Another well-documented mod that has to be done before the engine is installed is to make a hole in the bell housing to allow clearance for the 100E starter motor shaft which is longer than that on the 93A. It has been suggested that the whole 'bulge' of the bell housing is cut or knocked off but that seems a bit crude. My method was to drill a circle of small holes, knock the middle out, then open out and clean up the hole with a small grinding wheel in the electric drill. It is difficult to know the exact position of the

hole and I found that a trial installation was necessary. The future plan is to make a tin cover for the part that sticks out, but this is low priority.

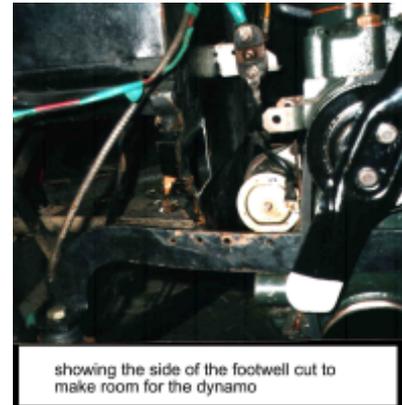
Another useful purpose of a trial installation was to assess the width problems of the oil filter and the dynamo. Because the 100E has a water pump and therefore the fan is on the front of the engine there is no other practical position for the dynamo than it's own bracket on the side of the engine. As shown in the photographs, it is just possible to modify the tinwork of the driver's footwell to allow room for the dynamo (even when the fan belt is fully adjusted) and still leave room for the dip switch and to get your foot on the clutch pedal. Because the dynamo is mounted lower than on the E93A engine it is necessary to make up new leads from the voltage regulator.

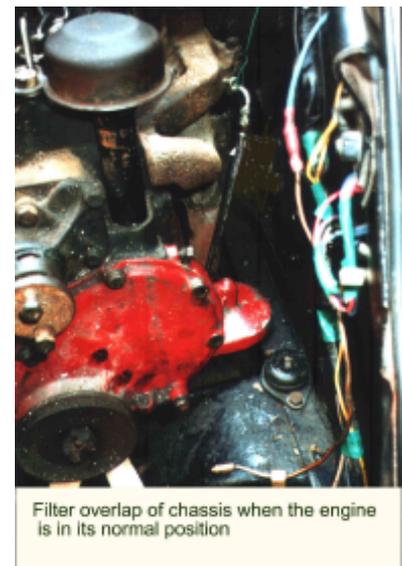
The problem of the oil filter is more difficult to overcome. The recent picture in the February 2003 edition of SVN shows one method, the flanges of the chassis are heated and folded inwards. I decided this was too brutal and meant losing the left hand suspension bump stop which is fitted under the chassis member at that position. Another solution is to retain the small rear timing cover casting from the 93A which would expose the oil holes in the block. These are the points at which the old 'export spec' remote-mounted oil filter pipes are connected. These holes can be tapped with a bsp thread to take the relevant unions. A filter kit is available but it costs the best part of £100. Apart from the cost I wanted to keep as many of the 100E parts as possible, so another solution was needed.

The oil filter casting overlaps the chassis by less than an inch so the rather radical method used was to move the front of the engine 22mm to the right. This meant a bit more tin bashing to make room for the dynamo but everything just went in. The top of the engine mounting bar is flat in the crucial area so it is only necessary to drill two new bolt holes and push the front of the engine to the right. A slight joggle in the bar ensures that the central part still lies flat across the front of the timing cover and the ends align with the engine mountings. In order to allow the gear-box to also swing to the right the two heavy tie rods must be slacked fully off and once the engine position has been finalised suitable spacers will be needed so that the tie rods can be properly tightened. I found that about 5mm of spacers were required at the front of the left hand rod and the rear of the right hand rod. The prop shaft and universal joint will have no problem coping with the angle of the engine, they already cope with much greater angular movement in the vertical plane.

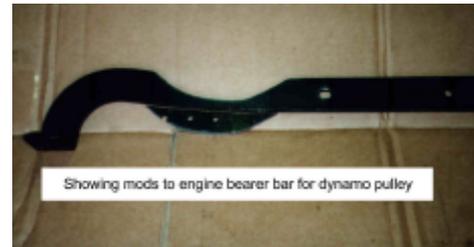
At this point it was realised that although the dynamo didn't foul the bodywork it was not possible to fit its pulley because of the position of the engine bearer bar. The remedy, as illustrated in the pictures, was to cut a piece from the top of the bar and, to retain the strength, weld it back on the bottom. By the way, you can use the 93A dynamo but it is necessary to use the pulley from the 100E due to the narrower section of the fan belt.
