100E into E83W will go (just)

(The story of how Noddy, an E83W pick-up, received a 100E engine)

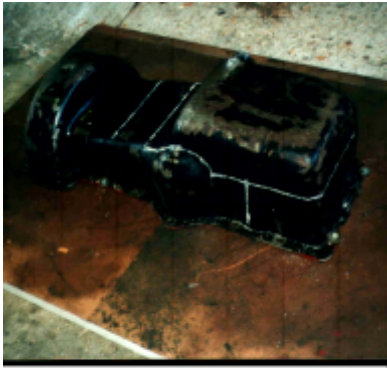
Original sump marked-up for cutting.

The shape of the sump (deep part at the front) is the most obvious problem when considering the installation of a 100E engine in any 'upright' Ford. They have their front axle and steering rods just below the front of the engine. The way to do it when converting a car has been well documented but the E83W has heavier steering and suspension and more ground clearance than the cars so even the deep part is well clear of the track rod. The photographs show various stages of the sump conversion which basically involves moving the deep part further back. It's not straightforward (nothing is) because the sump tapers towards the front and has a bulge at the side to accommodate the oil pump. If I were starting again the new front lower edge would be radiused rather than the sharp corner as shown, this turned out to be a very close fit to the flange on the chassis front cross member. During the welding process it is advisable to screw or clamp the sump flange to a suitable flat surface to avoid distortion. After welding fill it with paraffin to check for leaks.

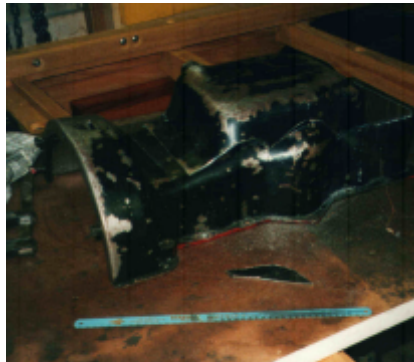
Deep part cut and moved back.

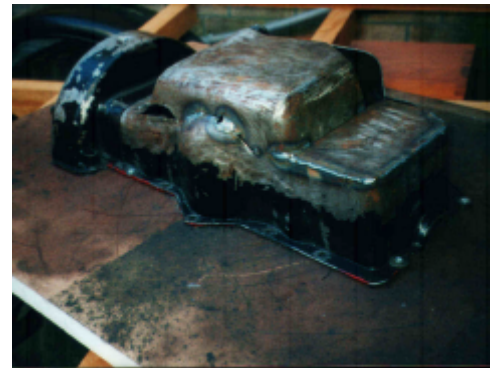
Part-way through the welding process.

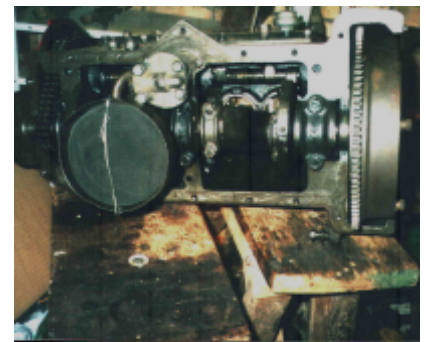
Oil pick-up pan in new position.

With the deep part of the sump repositioned it is necessary to move the oil pick-up but not by as much as when modifying for installation in a car. The necessary shift can be achieved by careful bending of the pipe between pick-up and pump. It is easier to check this when the main sump welding has been done but before all the holes are plated over. This allows you to see where the pick-up is fouling the sump during the bending process.

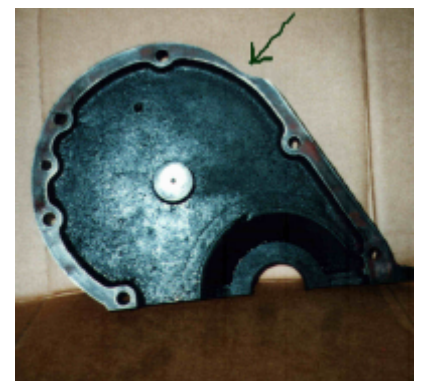
The timing chain cover after grinding to allow room for the water pump.

It is not practical to use the 100E engine mountings, which are on the sides of the engine, so the timing cover casting of the 93A must be retained in order to use the original engine front mounting bar. The castings are interchangeable but the old one will require a bit of grinding on the top edge to clear the water pump body. The picture shows that you should avoid being too heavy handed or the sealing face will be lost at this point.

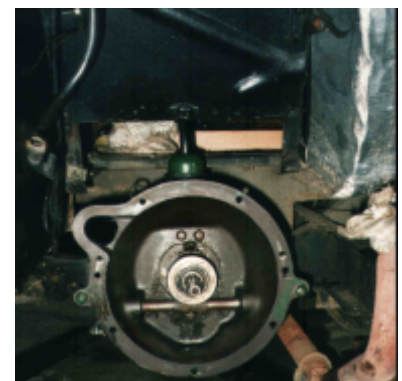
Hole in the bell-housing for the starter motor shaft.

Another well-documented mod that has to be done before the engine is installed is to make a hole in the bell housing to allow clearance for the 100E starter motor shaft which is longer than that on the 93A. It has been suggested that the whole 'bulge' of the bell housing is cut or knocked off but that seems a bit crude. My method was to drill a circle of small holes, knock the middle out, then open out and clean up the hole with a small grinding wheel in the electric drill. It is difficult to know the exact position of the

hole and I found that a trial installation was necessary. The future plan is to make a tin cover for the part that sticks out, but this is low priority.

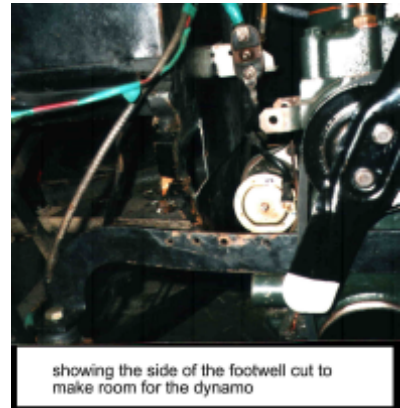
Another useful purpose of a trial installation was to assess the width problems of the oil filter and the dynamo. Because the 100E has a water pump and therefore the fan is on the front of the engine there is no other practical position for the dynamo than it's own bracket on the side of the engine. As shown in the photographs, it is just possible to modify the tinwork of the driver's footwell to allow room for the dynamo (even when the fan belt is fully adjusted) and still leave room for the dip switch and to get your foot on the clutch pedal. Because the dynamo is mounted lower than on the E93A engine it is necessary to make up new leads from the voltage regulator.

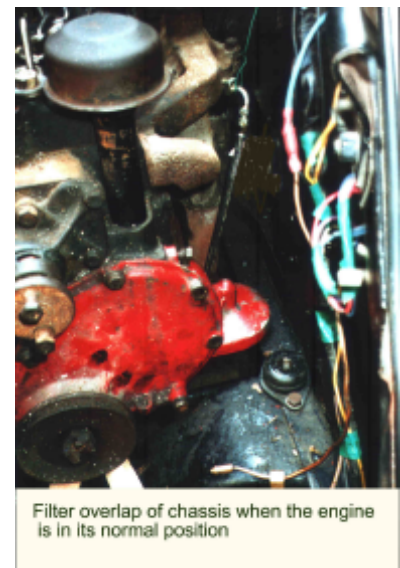
The problem of the oil filter is more difficult to overcome. The recent picture in the February 2003 edition of SVN shows one method, the flanges of the chassis are heated and folded inwards. I decided this was too brutal and meant losing the left hand suspension bump stop which is fitted under the chassis member at that position. Another solution is to retain the small rear timing cover casting from the 93A which would expose the oil holes in the block. These are the points at which the old 'export spec' remote-mounted oil filter pipes are connected. These holes can be tapped with a bsp thread to take the relevant unions. A filter kit is available but it costs the best part of £100. Apart from the cost I wanted to keep as many of the 100E parts as possible, so another solution was needed.

The oil filter casting overlaps the chassis by less than an inch so the rather radical method used was to move the front of the engine 22mm to the right. This meant a bit more tin bashing to make room for the dynamo but everything just went in. The top of the engine mounting bar is flat in the crucial area so it is only necessary to drill two new bolt holes and push the front of the engine to the right. A slight joggle in the bar ensures that the central part still lies flat across the front of the timing cover and the ends align with the engine mountings. In order to allow the gear-box to also swing to the right the two heavy tie rods must be slacked fully off and once the engine position has been finalised suitable spacers will be needed so that the tie rods can be properly tightened. I found that about 5mm of spacers were required at the front of the left hand rod and the rear of the right hand rod. The prop shaft and universal joint will have no problem coping with the angle of the engine, they already cope with much greater angular movement in the vertical plane.

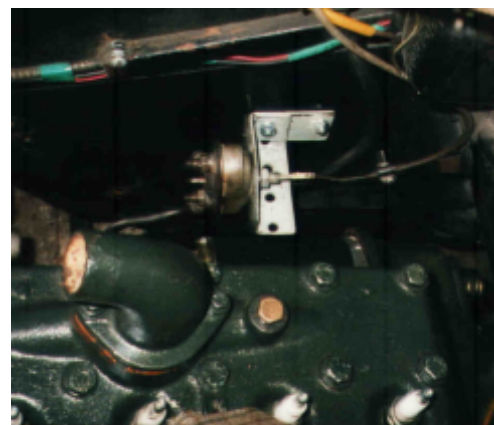
The starter switch on new bracket.

The 100E uses a remote switch for the starter motor which is mounted on the engine bulkhead. To avoid changing the E83W starter cable I mounted the 100E switch on a bracket fixed to the side of the driver's footwell at a point just above the starter motor. The battery leads from the 100E are just about the right length in this position.
